NATICK/76-062 - CEMEL

**FLAME TEST FOR MEDICAL UNIT,
SELF-CONTAINED TRANSPORTABLE
(INFLATABLE SHELTER ASSEMBLY)**

24 June 1977

UNITED STATES ARMY
NATICK RESEARCH and DEVELOPMENT COMMAND
NATICK, MASSACHUSETTS 01760

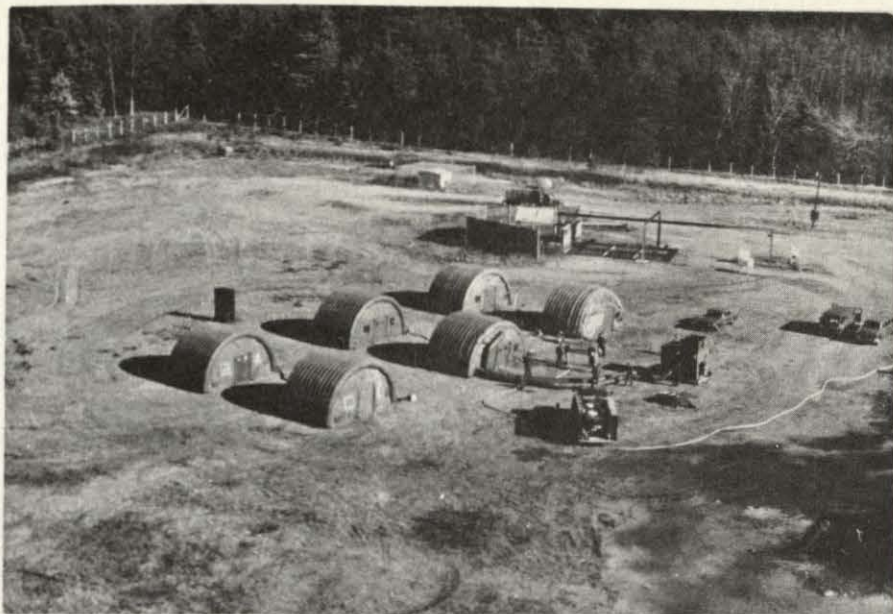
Figure 2. MUST Shelters at Sudbury Annex

The inflatable shelter, with two end panels installed, was connected through an air duct to a Utility Element which supplied recirculated air through the test unit and bleed air for inflating the cells. The airflow was throttled in such a manner that a flow of approximately 400 cfm of air ($.19 \text{ m}^3/\text{s}$) was moving into the shelter. The shelter section was erected to a gage pressure of approximately 1.5 psi ($10.3 \times 10^3 \text{ Pa}$) and was pressurized internally to 0.2 to 0.4 inches of water (49.8 to 99.6 Pa). The Utility Element was positioned a safe distance from the test unit with added lengths of ducting and cabling as required (see Figure 2). The fuel supply was located approximately 200 feet (61 m) from the test unit.

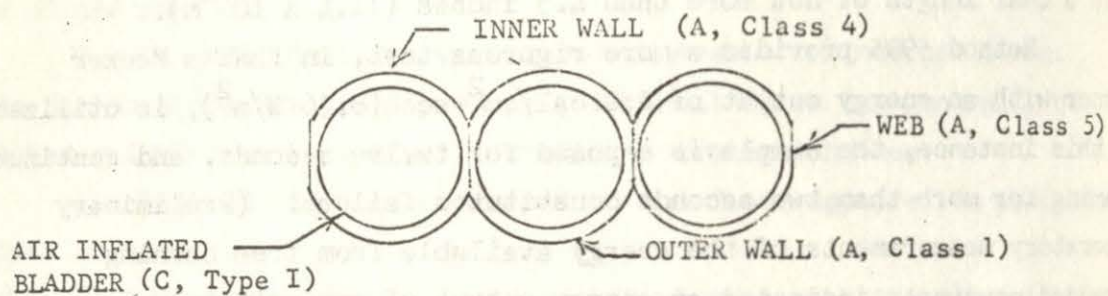
Fig. 24 Inflated Side Walls

Diagram of Inflated Side Walls with
Identification of Basic Materials. (Ref. Table 3)

A comparison of Figures 24, 25, and 26, and Table 3 shows that the exterior surfaces of the shelter and the interior surface of the end panels are polyester fabric, coated on both sides, and are required to meet a flame-resistance test, while the remaining inner surfaces are polyester fabrics coated on the exposed side only and are not required to be flame resistant.

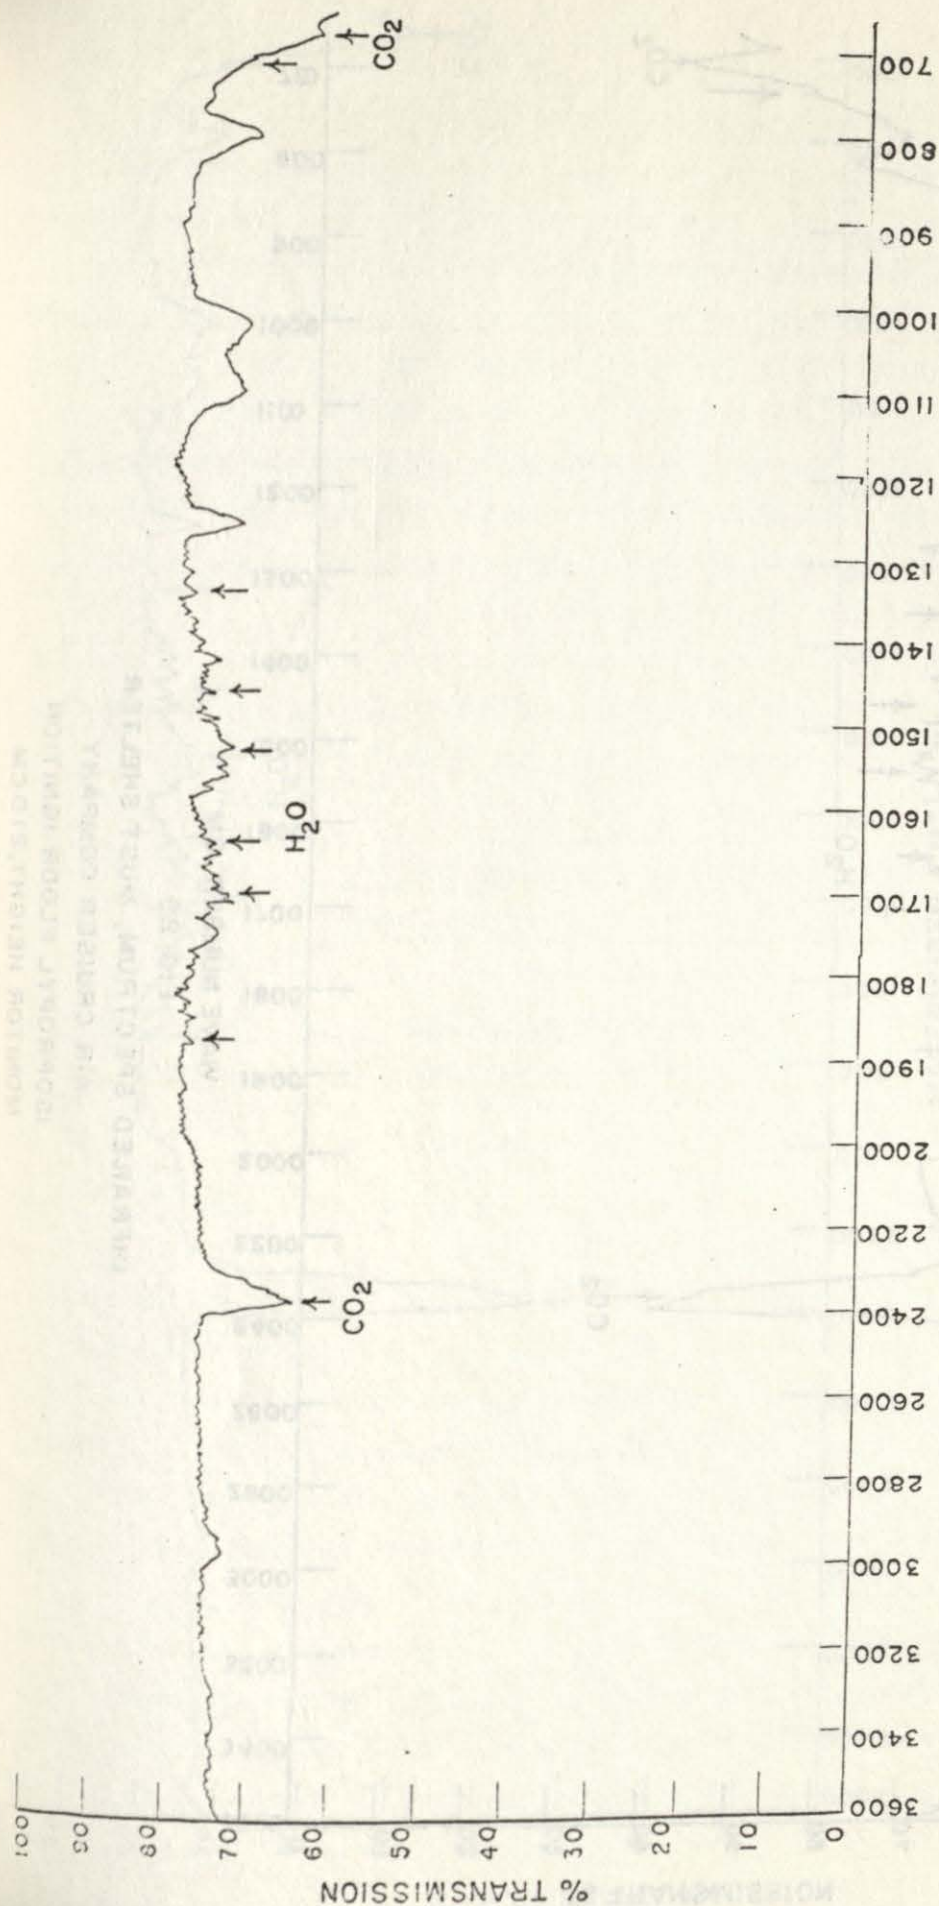
In addition to the Raman spectra cited, additional gas samples were analyzed by infrared techniques and again compared to laboratory air. The spectra obtained in these analyses are shown in Figures 28 to 30. These spectra also show an increased presence of H_2O and CO_2 in the gases collected within the shelter, but no presence of materials normally considered toxic.

FIG. 28
INFRARED SPECTRUM, AIR BACKGROUND
CELL PATH, 1 METER

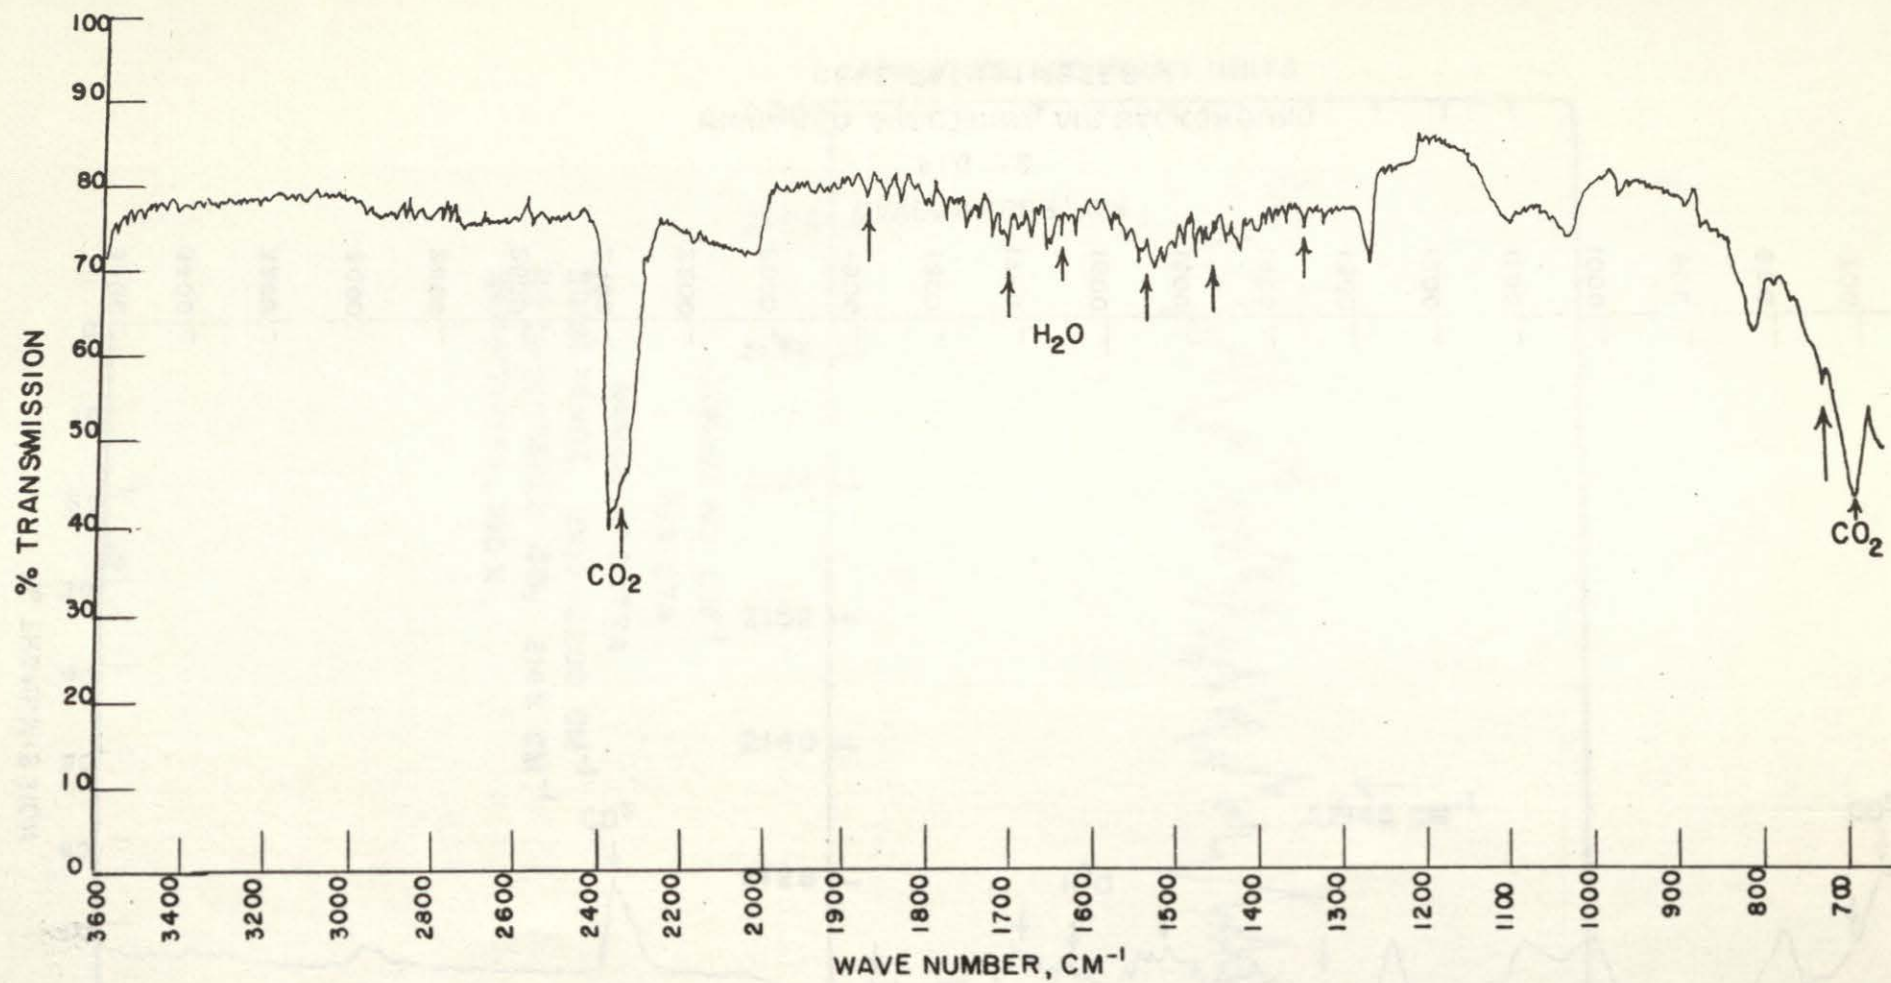
FIG. 29

INFRARED SPECTRUM, MUST SHELTER
AIR CRUISER COMPANY
ISOPROPYL FLOOR IGNITION
MONITOR HEIGHT, 210 CM

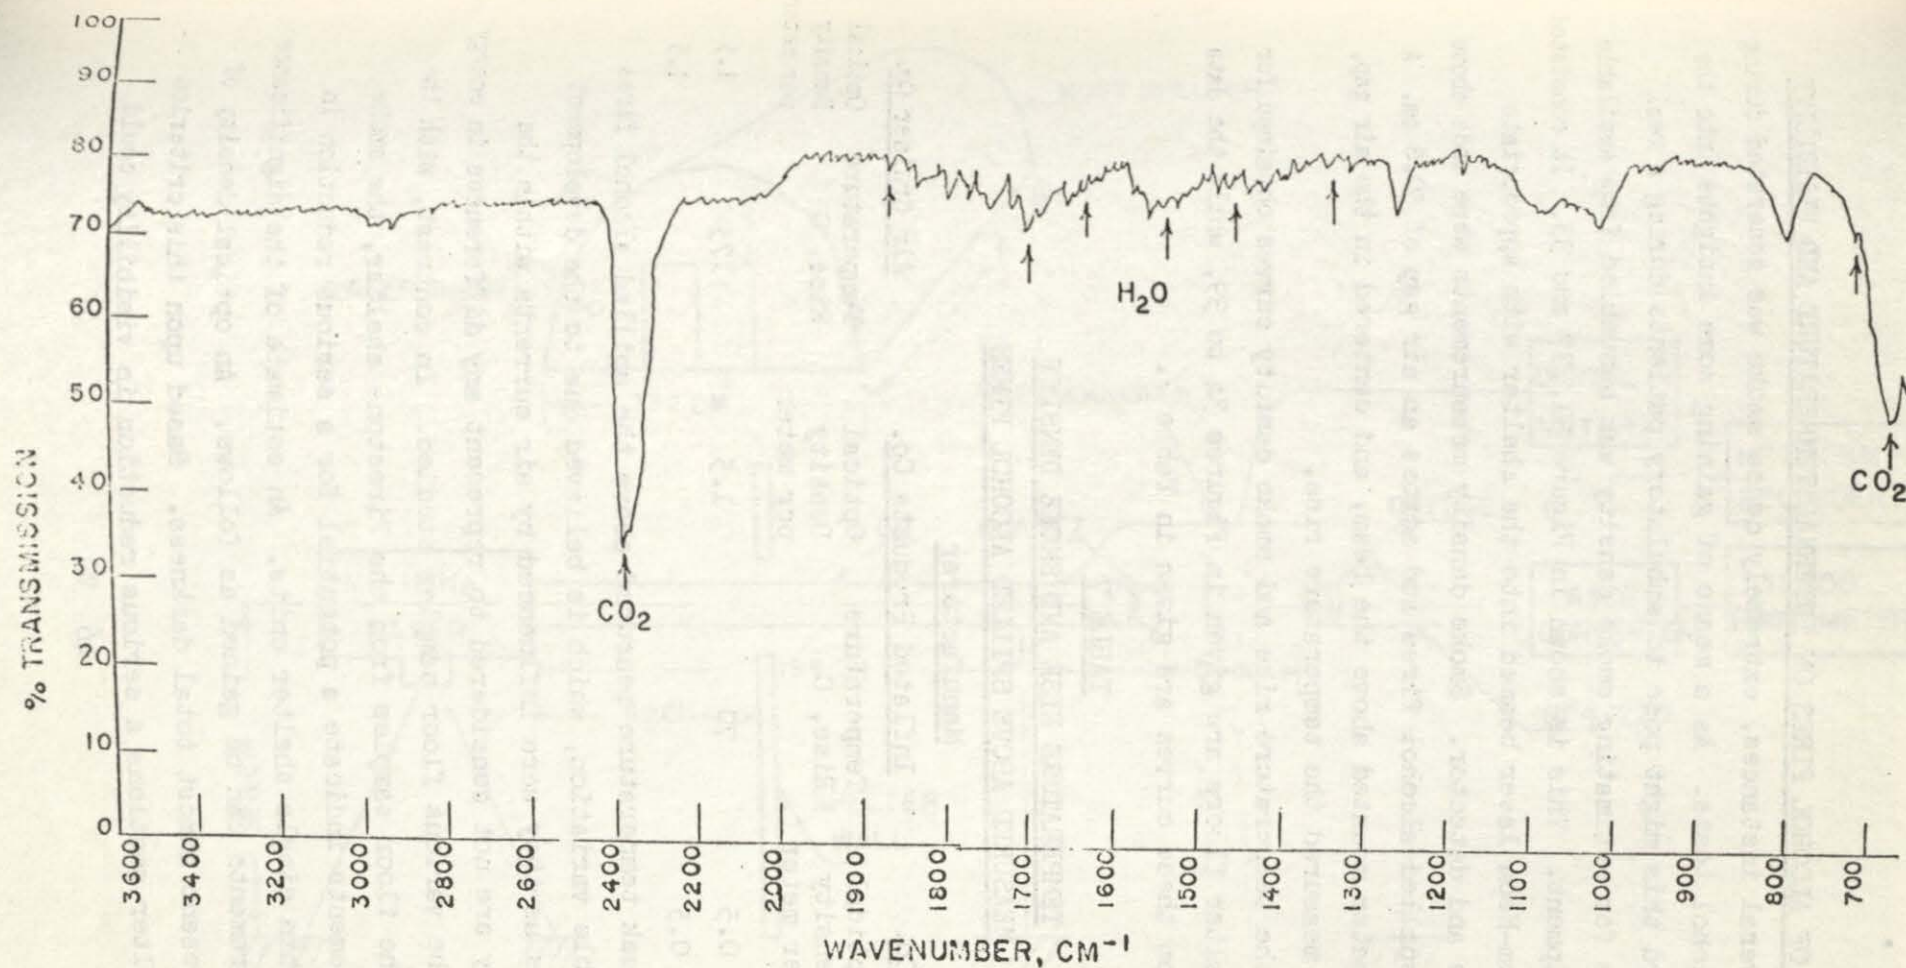
FIG.

INFRA RED SPECTRUM, MUST SHELTER
AIR CRUISER COMPANY
ISOPROPYL FLOOR IGNITION,
MONITOR HEIGHT, 100 CM

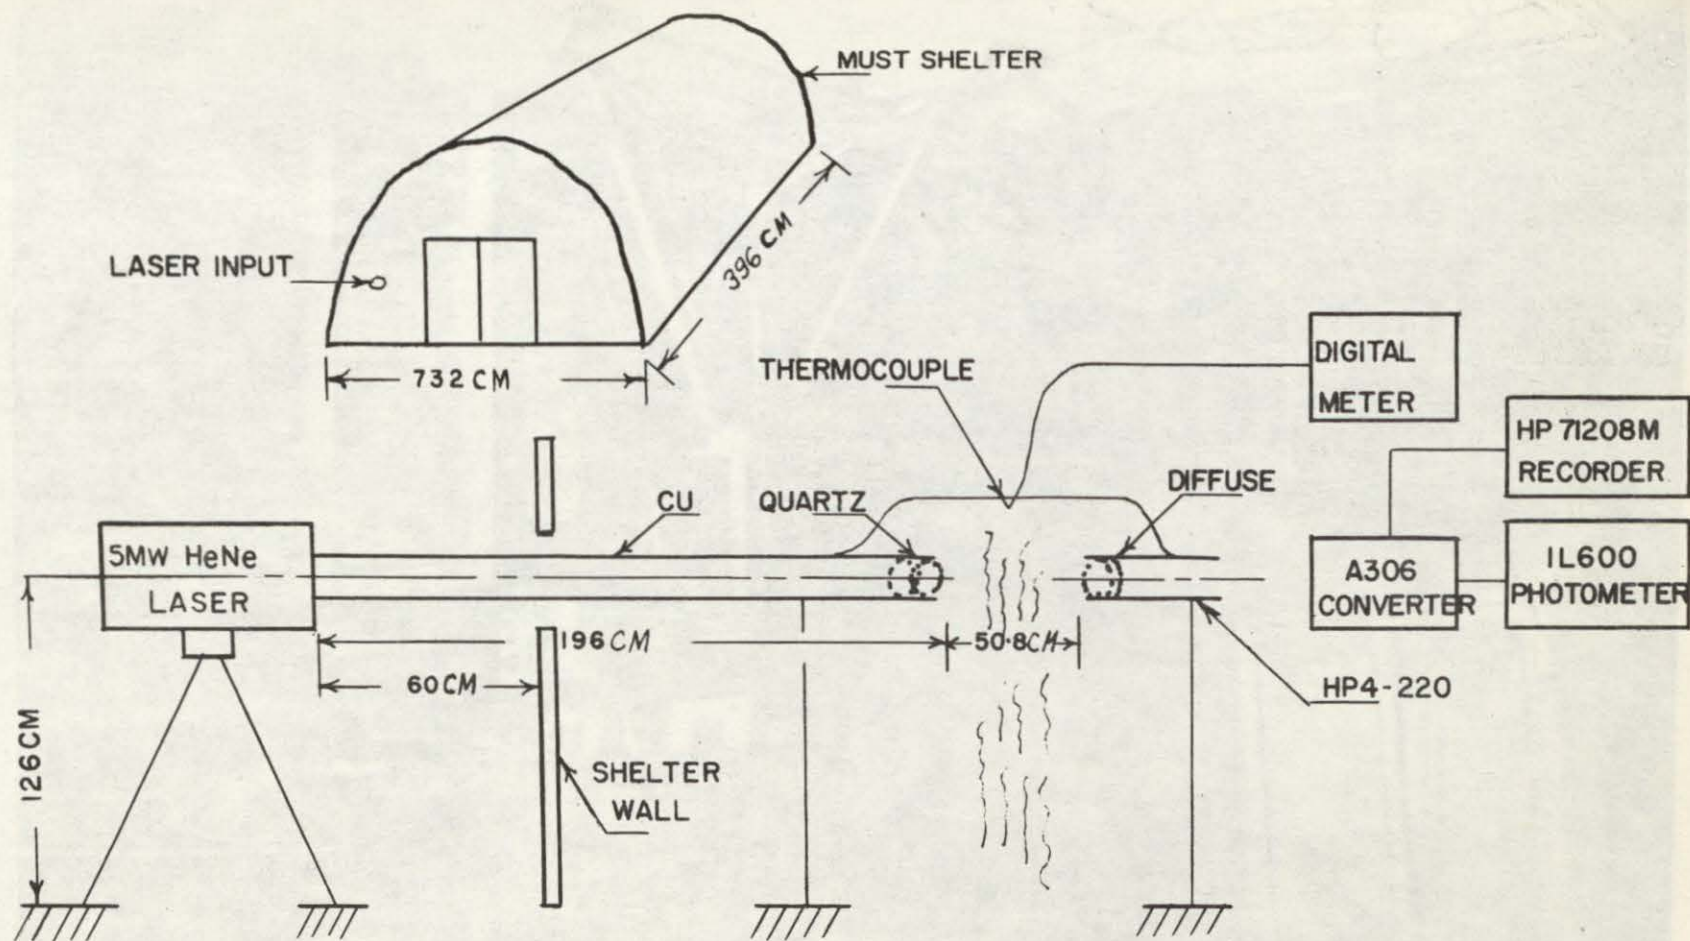
In several instances, extremely dense smoke was generated during the spilled alcohol tests. As a means of gaining some insights into the potential hazard this might pose to ambulatory patients during a real event, a device for estimating smoke density was assembled from available laboratory equipment. This is shown in Figure 31, 32 and 33. It consisted of a 5-mW Helium-Neon laser beamed into the shelter with appropriate optical windows and detector. Smoke density measurements were made above the simulated spilled alcohol fires and across an air gap of 50.8 cm. A digital thermometer mounted above the beam, and centered in the air gap, simultaneously measured the temperature rise.

FIG-31
SCHEMATIC DIAGRAM FOR SMOKE DENSITY
AND TEMPERATURE MEASUREMENTS

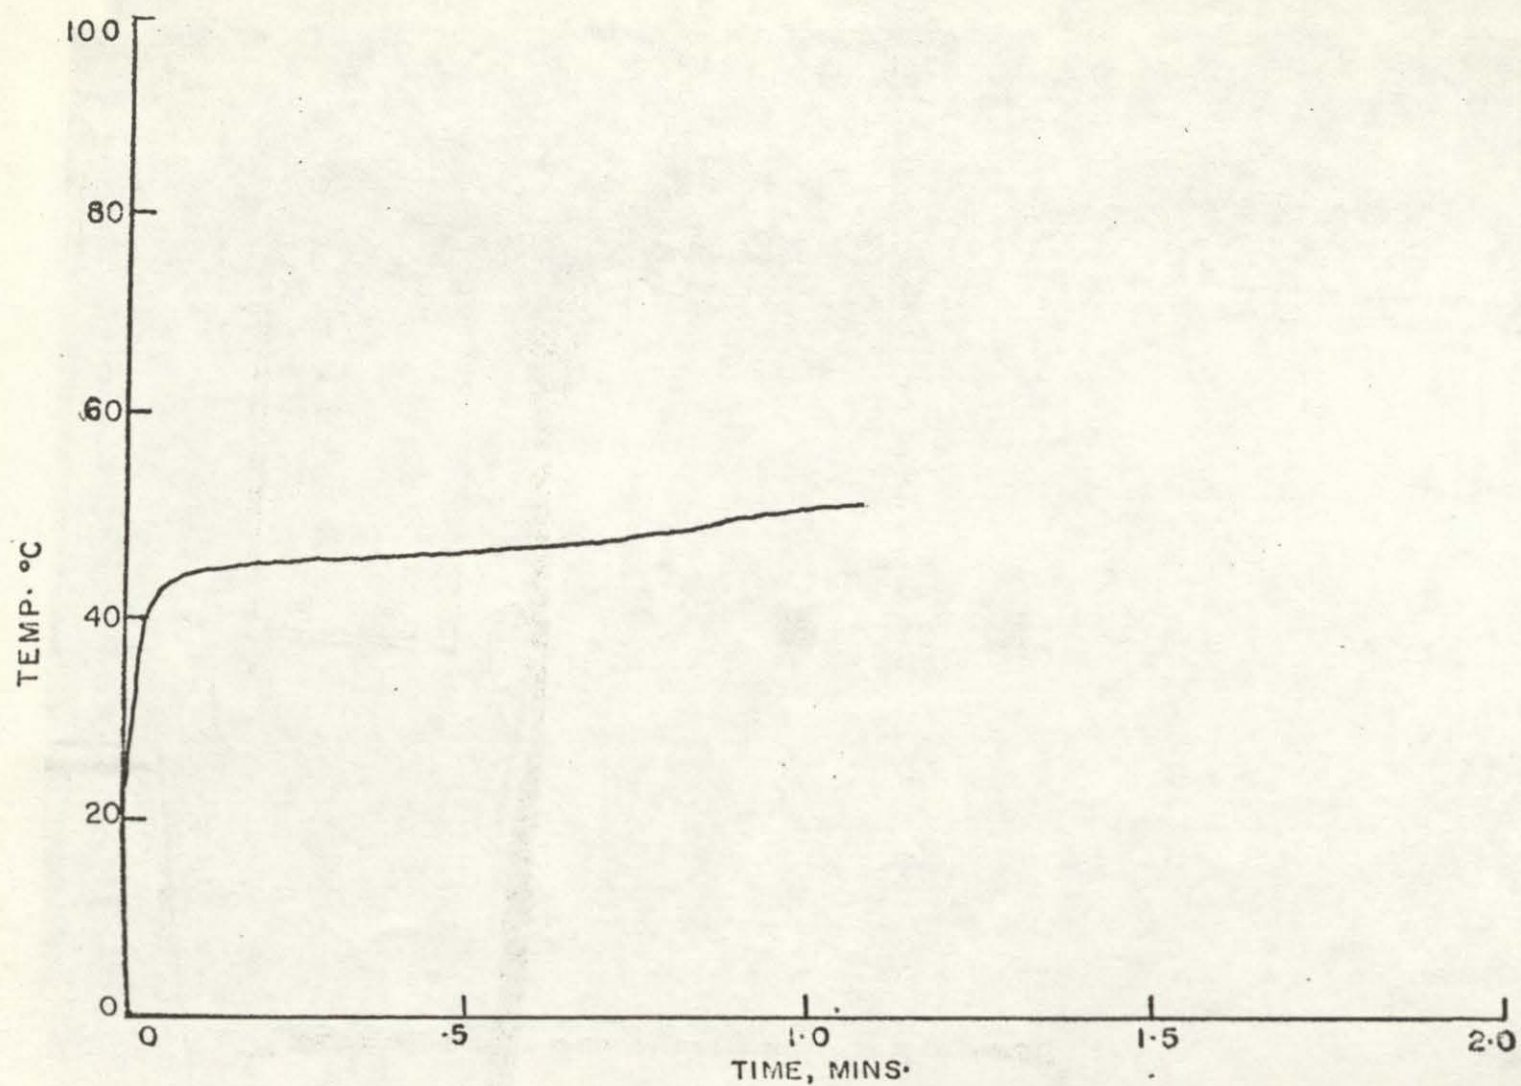
Both the temperature rise and smoke density curves obtained for the various shelter floors are given in Figures 34 to 39, while the data interpreted from these curves are given in Table 7.

The peak temperature measured above the spilled alcohol fires show considerable variation, which is believed due to the development of flame plumes as they were influenced by air currents within the shelters. They are not considered to represent any differences in energy generated by the various floor samples studied. In contrast, with the exception of the floor samples from the Firestone shelter, the smoke density measurements indicate a potential for a serious reduction in visibility within single shelter units. An estimate of the significance of these measurements can be gained as follows. An optical density of 3.0 would represent almost total darkness. Based upon this criterion for single shelter sections a serious reduction in visibility could

FIG-34
TIME TEMPERATURE PROFILE OF AIR DURING
BURNING OF SHELTER NO 2 FLOOR

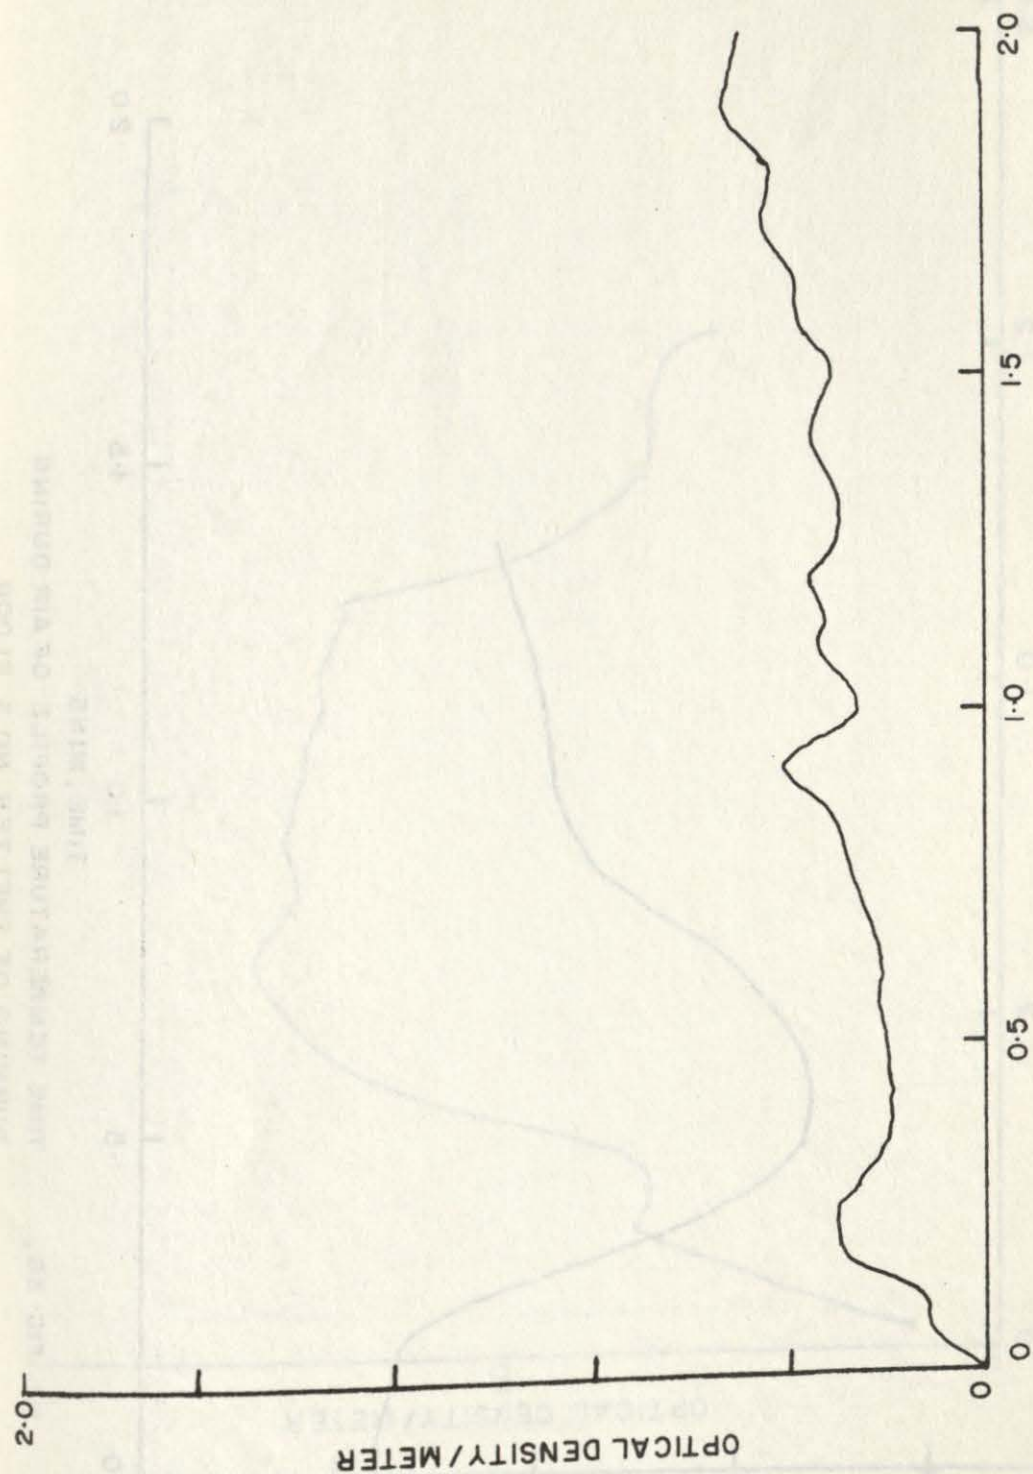
FIG.35, SMOKE DENSITY PROFILE DURING BURNING
OF SHELTER NO 2 FLOOR

occur at distances of 6, 2, and 2 meters for the Firestone, Inflated Products, and Air Cruiser Shelters, respectively, while total darkness could be anticipated at distances of 8, 2.7, and 2.7 meters. The optical density curves indicated these conditions would persist for the first one to two minutes, after which the shelter's exhaust system would clear the air.

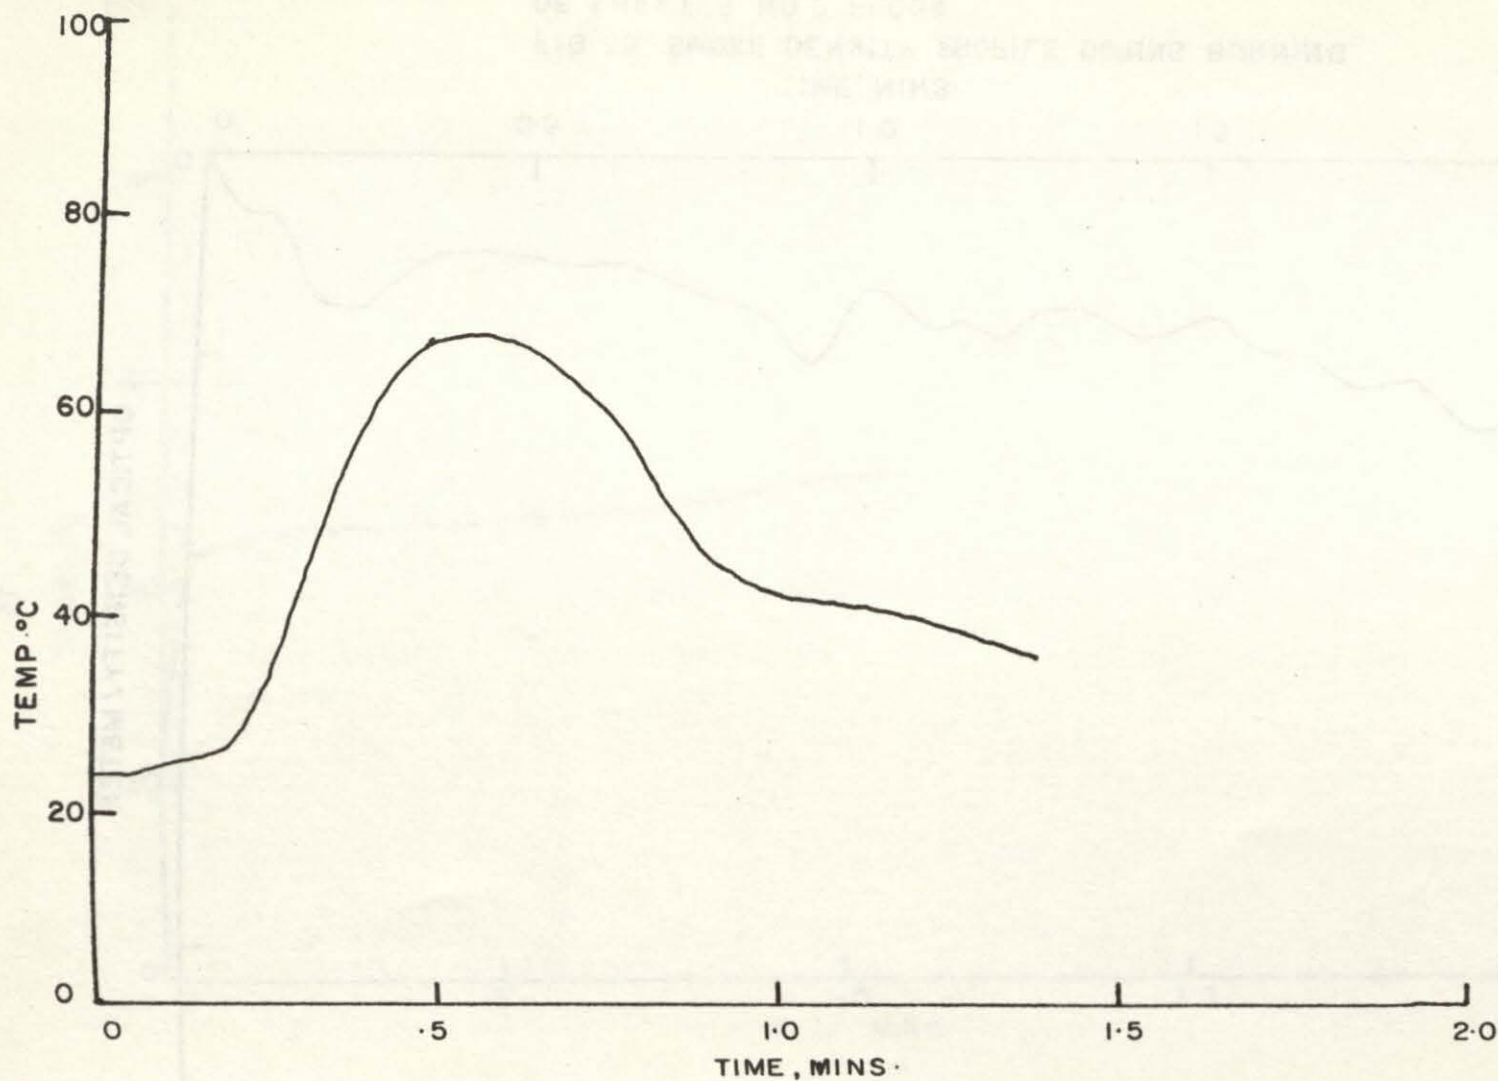
FIG. 36,

TIME TEMPERATURE PROFILE OF AIR DURING
BURNING OF SHELTER NO 3 FLOOR

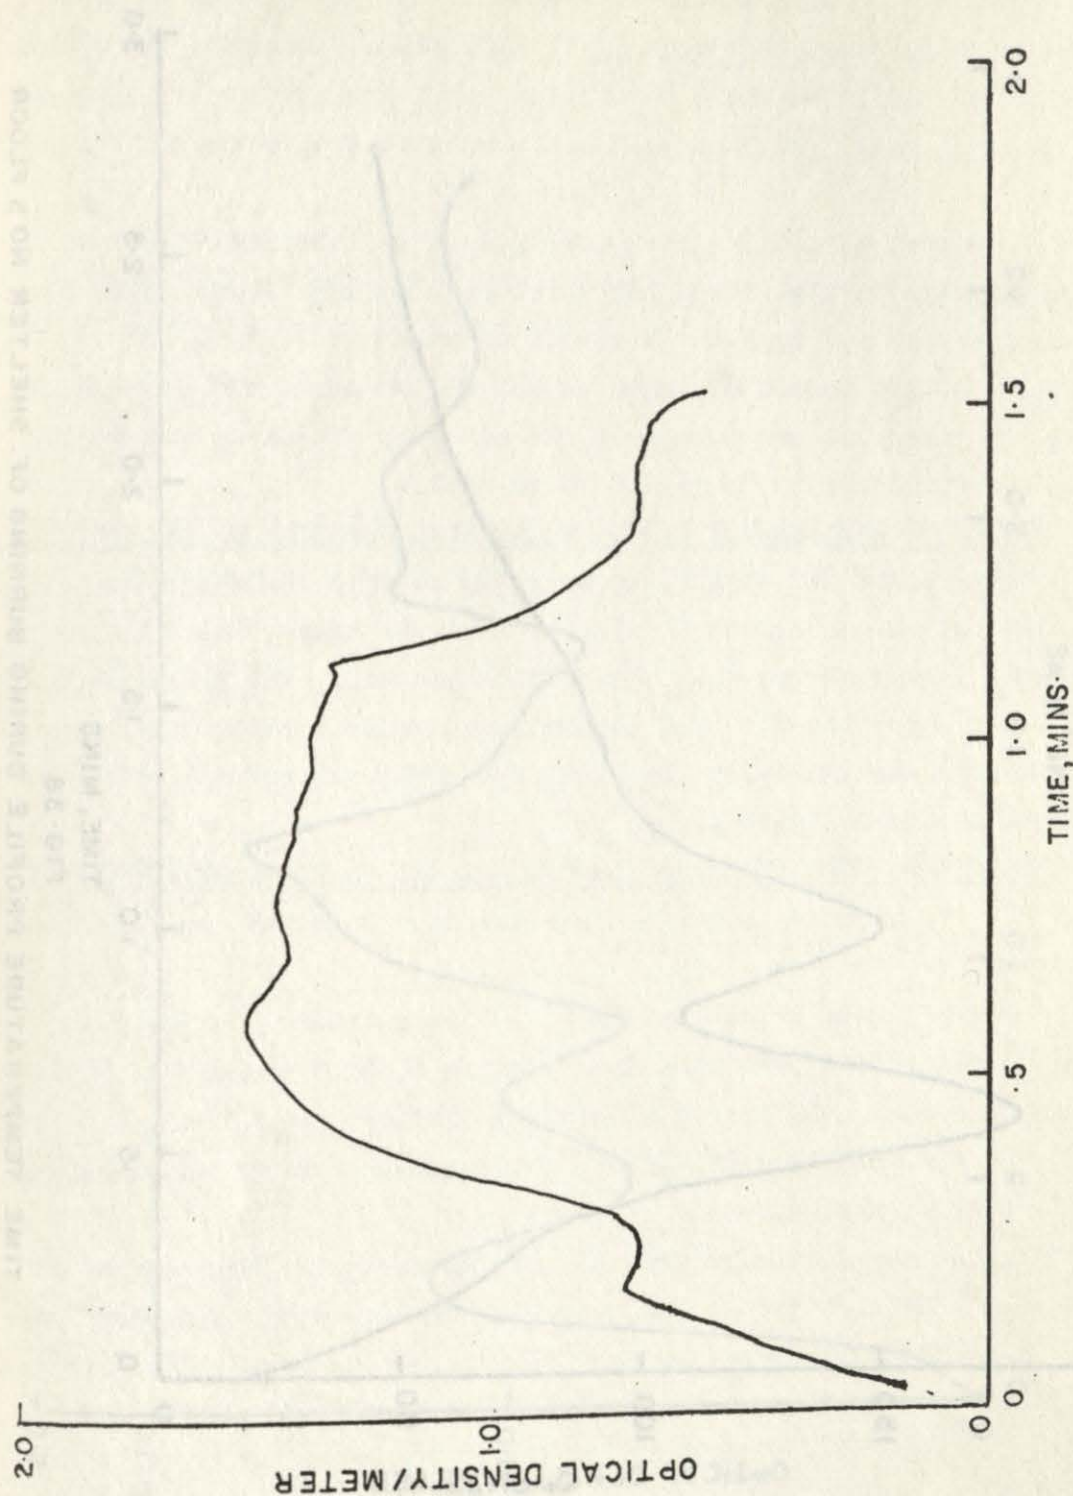
FIG-37, SMOKE DENSITY PROFILE DURING BURNING
OF SHELTER NO 3 FLOOR

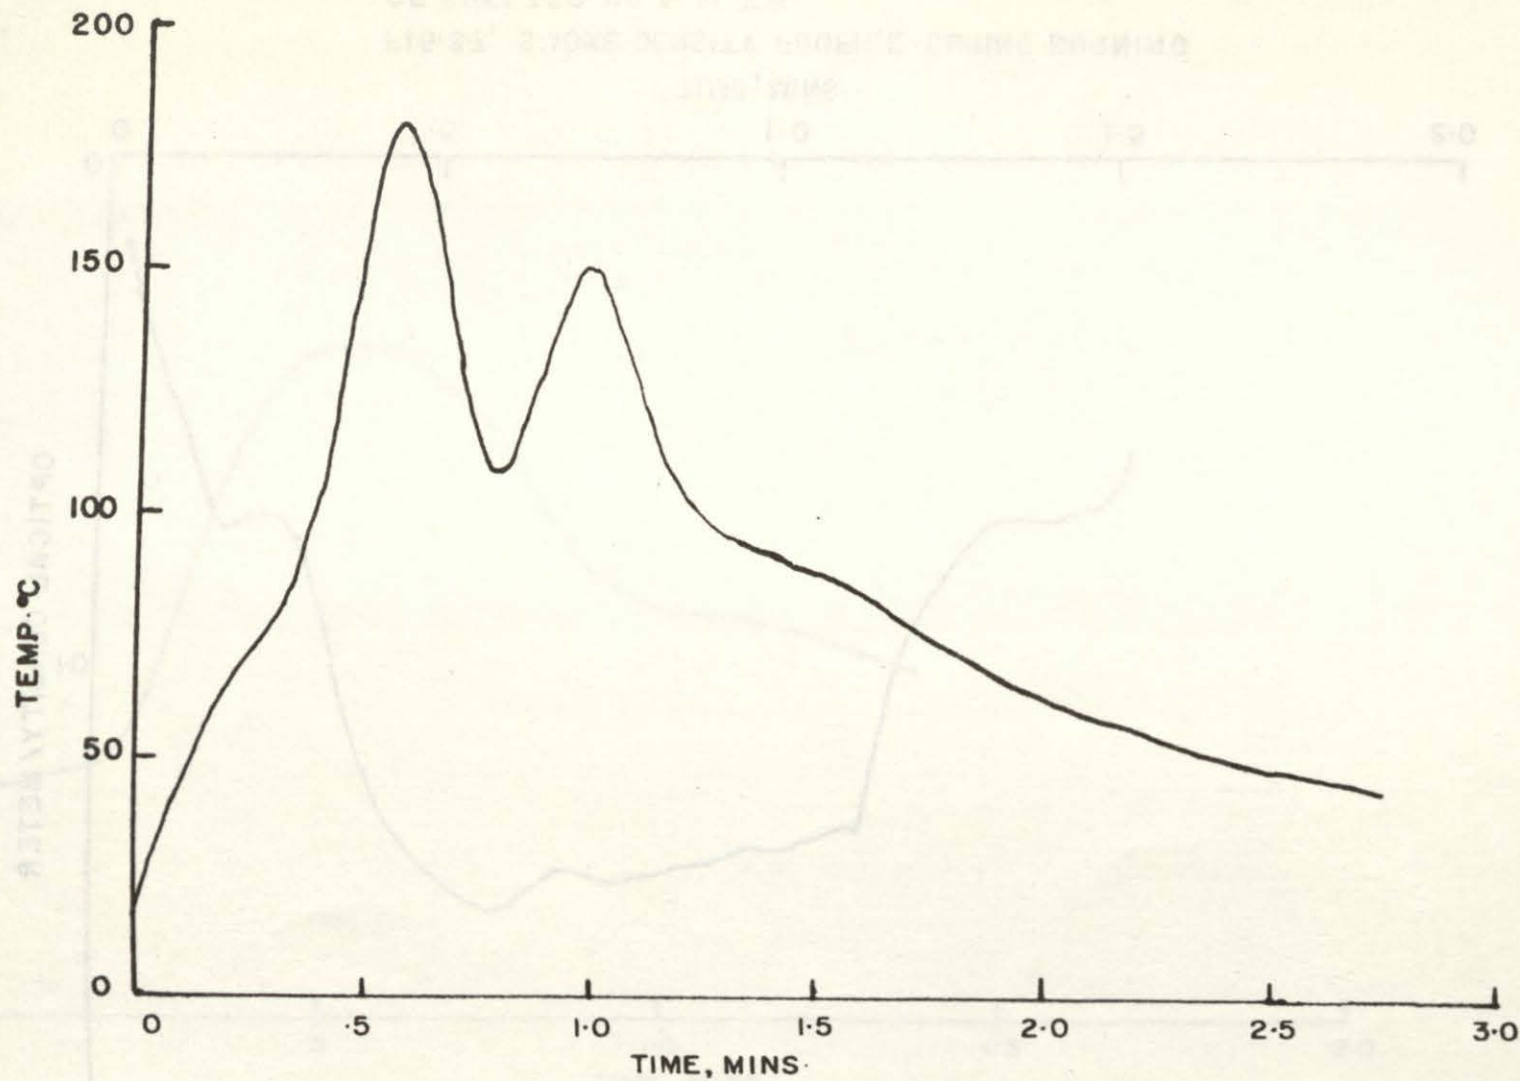
FIG-38

TIME TEMPERATURE PROFILE DURING BURNING OF. SHELTER NO 5 FLOOR

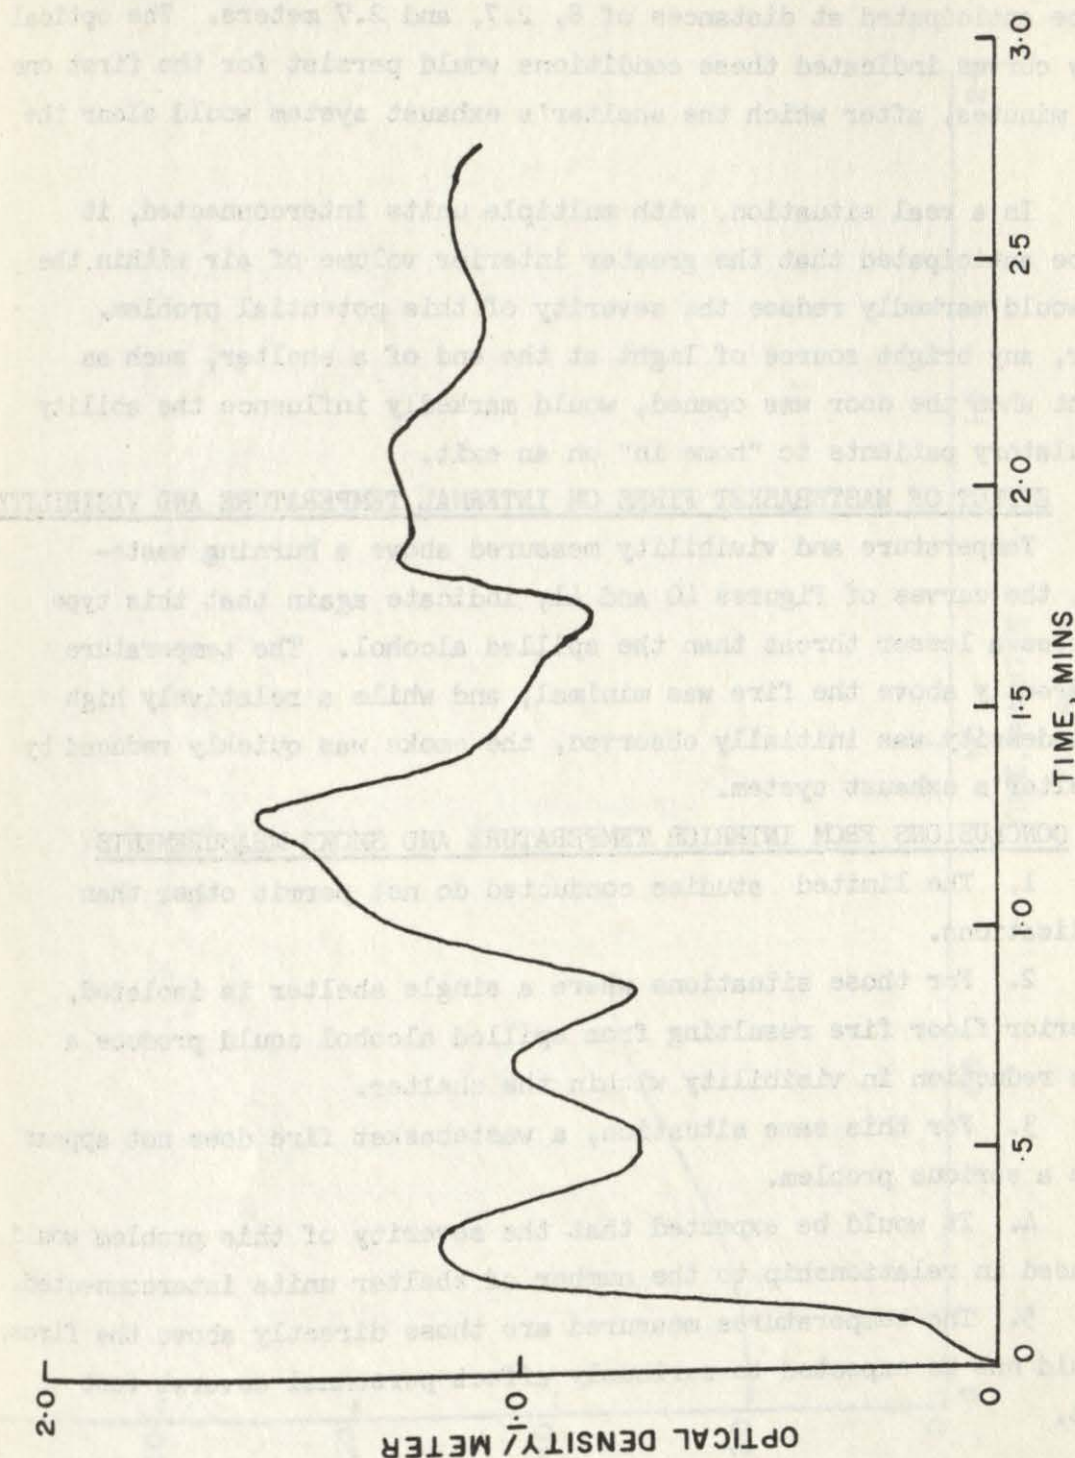
FIG. 39, SMOKE DENSITY PROFILE DURING BURNING OF SHELTER NO. 5 FLOOR
